# Home Energy Loss Inspection Survey

For: Client XXXX  
City, Prov.  
Postal

By: ThermoPhoto Imaging & Analysis  
15 Runnymede Cres.  
London, ON  
N6G 1Z7  
thermophoto@gmail.com

**Date:** 11/21/06

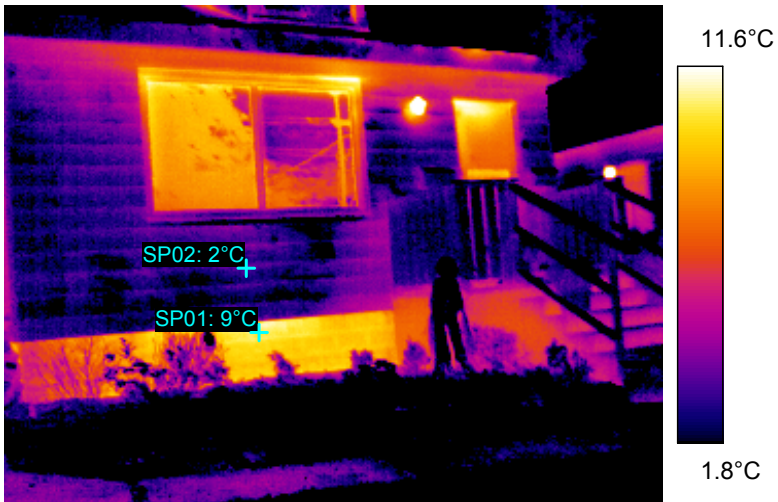
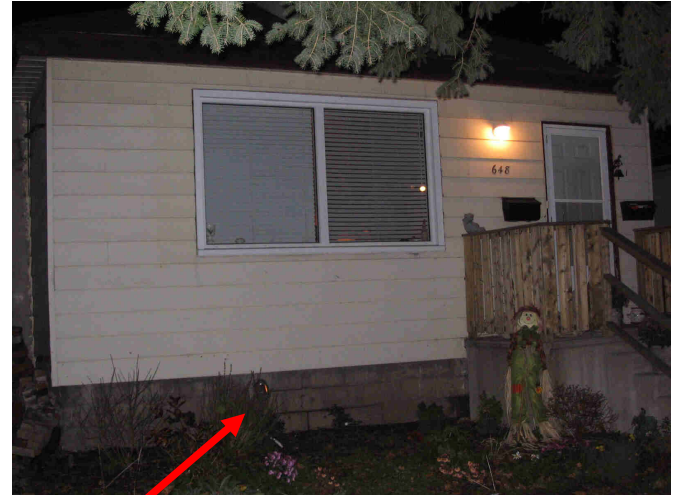
# Location: Front of House

Whole home was checked for energy loss. A few notable areas especially the in the basement where the foundation meets the framing of the home. See pages 4 & 5 for heat loss recommendations.

Notes: 7 degree C difference from spot 1 to spot 2 at base of home. Significant heat loss.

When insulating the basement paint the interior & exterior with a water proof seal. This will help prevent water ingress through the cement blocking during high winds and rain. Then vapor barrier and insulate with fiberglass batt recommended "R" Thickness of 8-10".

Insulate and vapor barrier basement at footing of home as discussed. Fiberglass Batt with an "R" Thickness of 8-10" recommended.

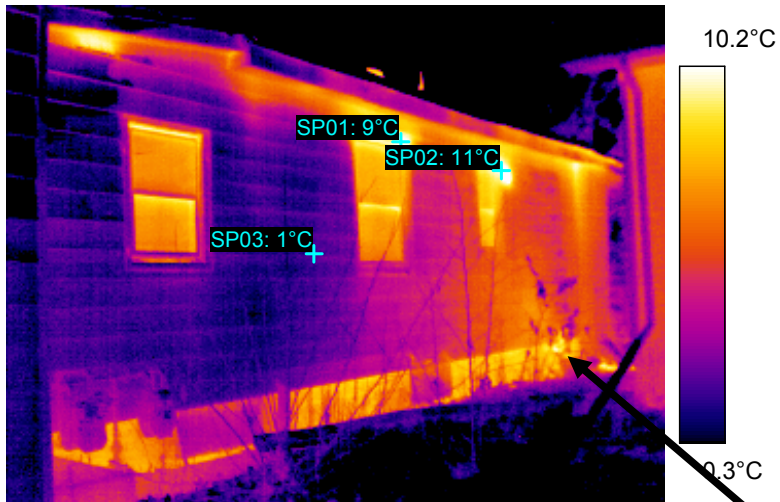
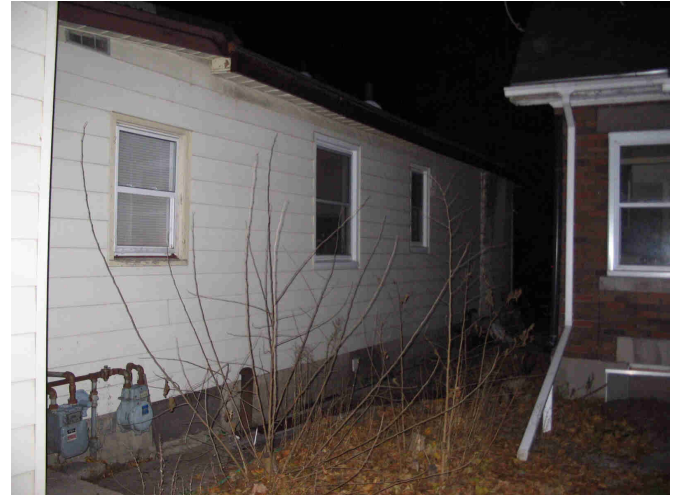
# Location: West side of home

Notes: Significant heat loss from top of west side windows. see spot comparison. Arrow points to major loss of heat out of side of building. Fire place was removed and retro-fit was not properly insulated.

Seal windows with weather striping or insulating foam. Re-insulate retro-fit if possible.

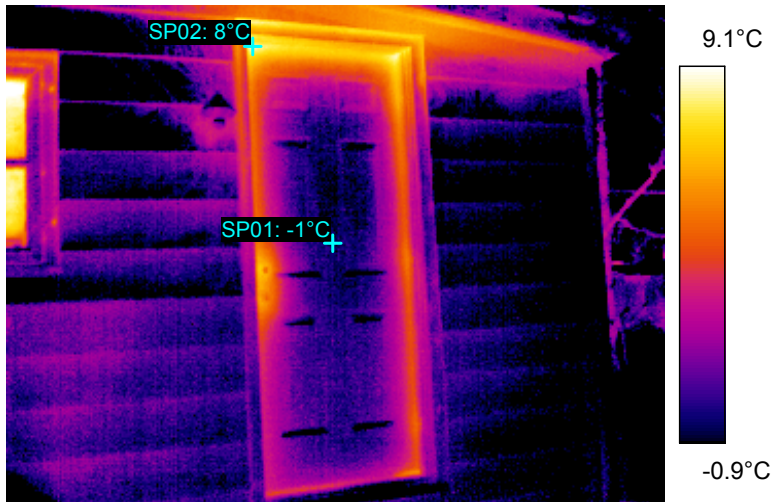
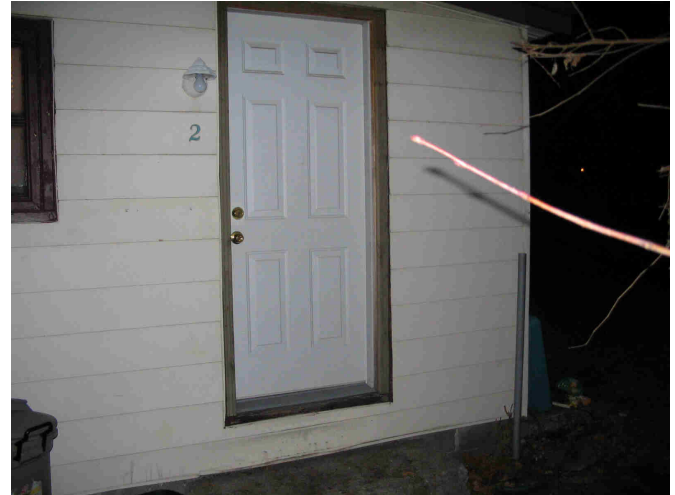
# Location: East side of home. Apt. B entrance

Notes: Heat loss at door seal.

Apply new weather stripping to provide better seal.

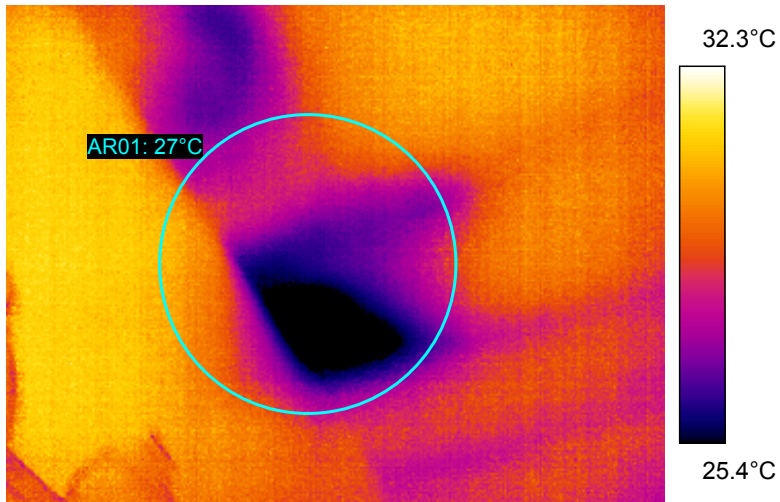
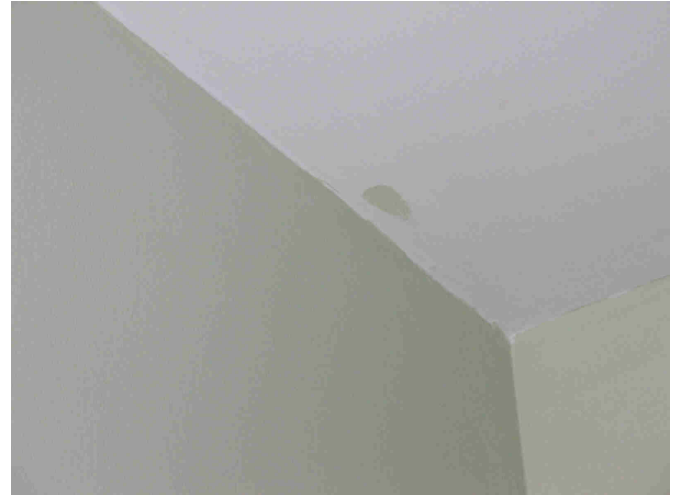
# Location: Bathroom, south-east, top corner

Notes: Moisture reading taken.  
acceptable level. Cold ingress noted.

Nothing to worry about. monitor to ensure no growth of cold ingress.

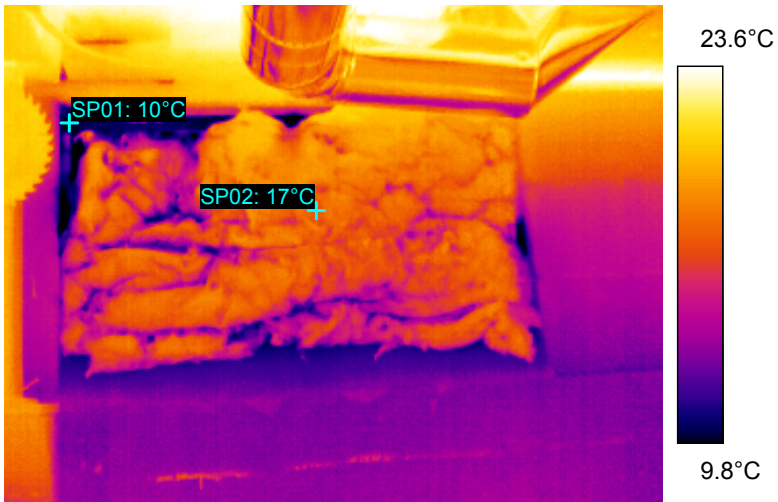
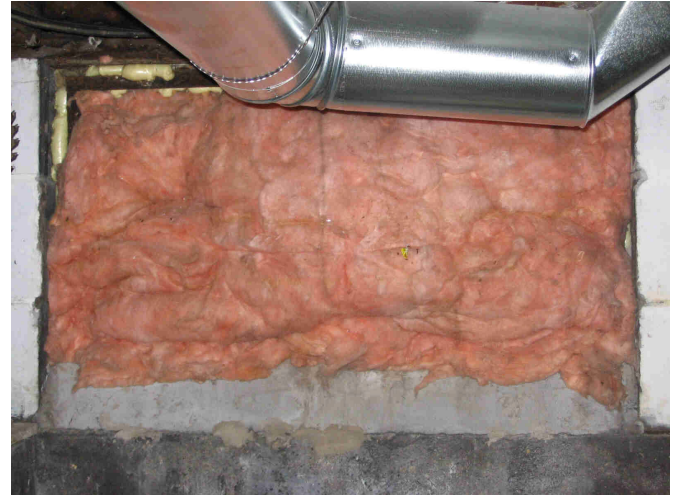
# Location: Basement Apt. A, west wall

Notes: basement window covered - west wall. 7 degree C. temp. difference.

Same problem noted with other two windows.

Re-adjust Insulation, or/ Re-insulate when basement is done.

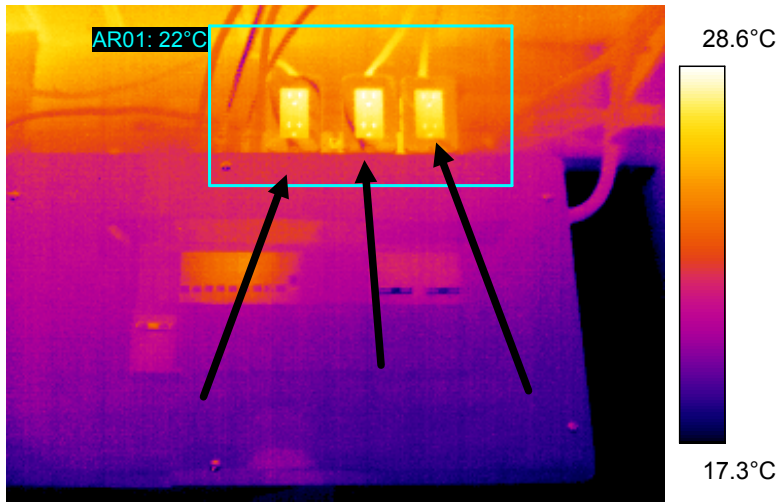
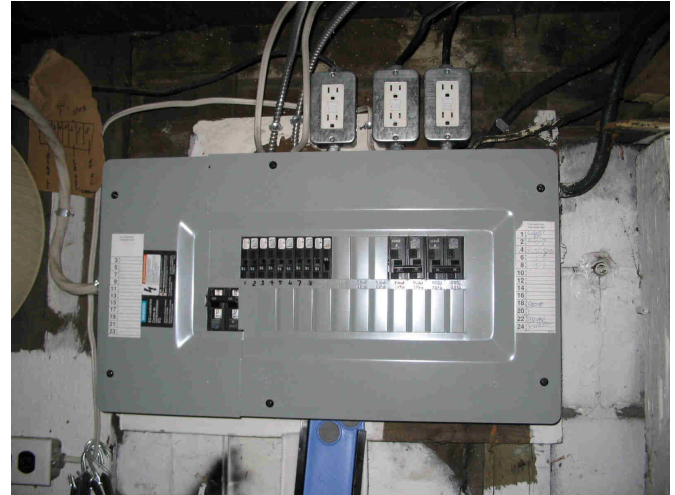
# Location: Fuse Box

All the homes outlets were checked along with the fuse box everything seemed fine except for three outlets attached to the down stairs fuse box. It is nothing to worry about but next time you have an electrician in have them check for loose connections . For more info. see page 9. Also investigate Apt. B, East bedroom for unknown anomaly.

Notes: Heat running up wires, cause most likely loose connections. No emergency. Everything else looks fine.

Tighten or have electrician check connections.

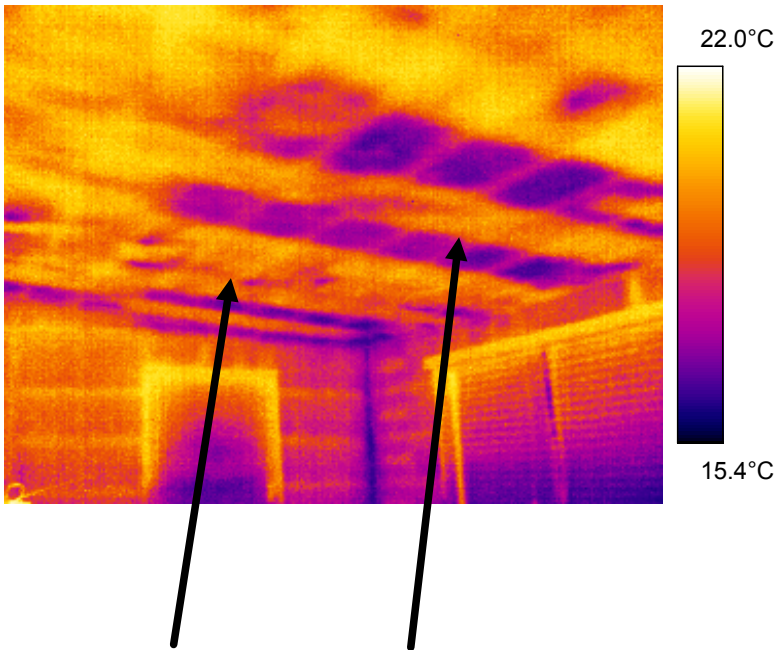
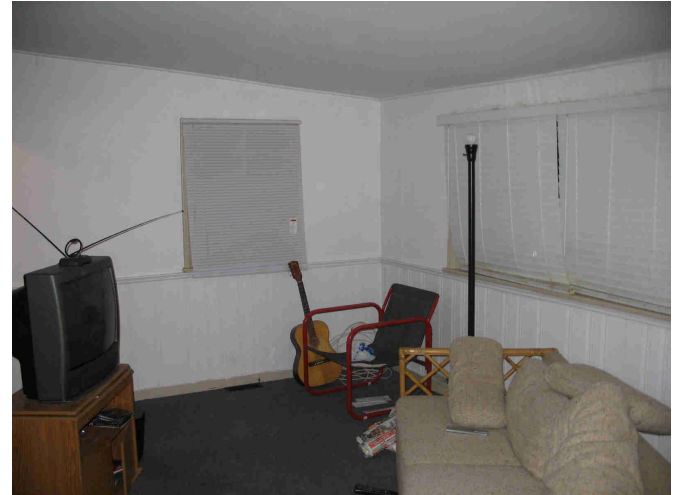
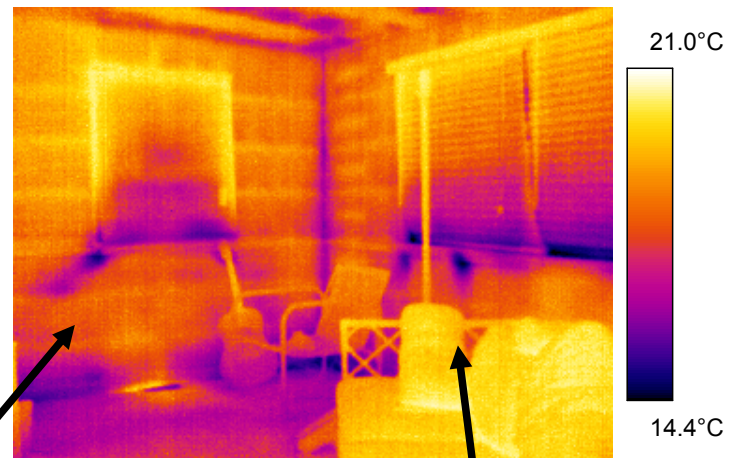
# Location: Apt. B, North room

Notes: Previous water damage spot, low moisture reading (top left image)

Air infiltration from windows (bottom right)

Ceiling studs running in wrong direction.

remove old damaged insulation, re-drywall,  
Tear down and properly re-build back partition.

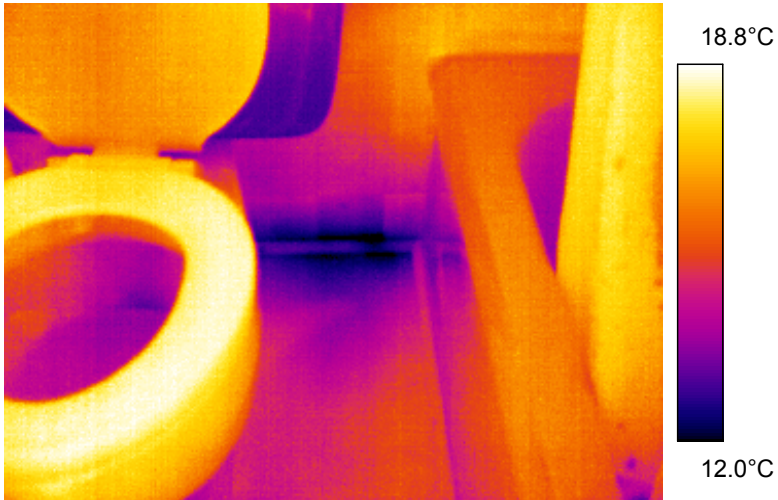
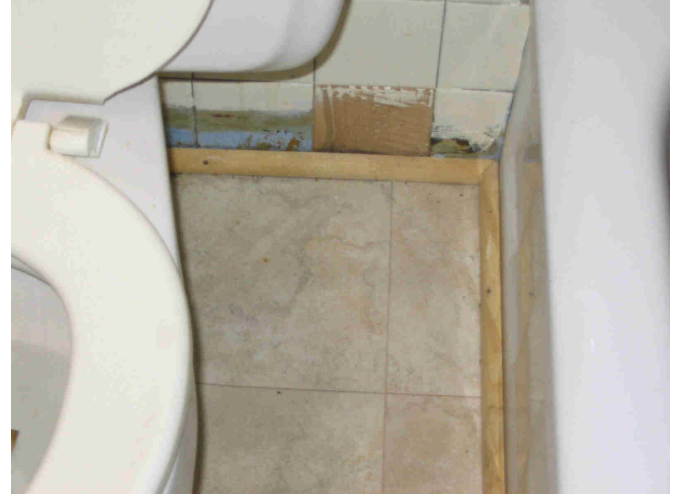
# Location: Apt. B, Bathroom

Notes: Cool air coming in.

Seal base with insulating foam then re tile open area.

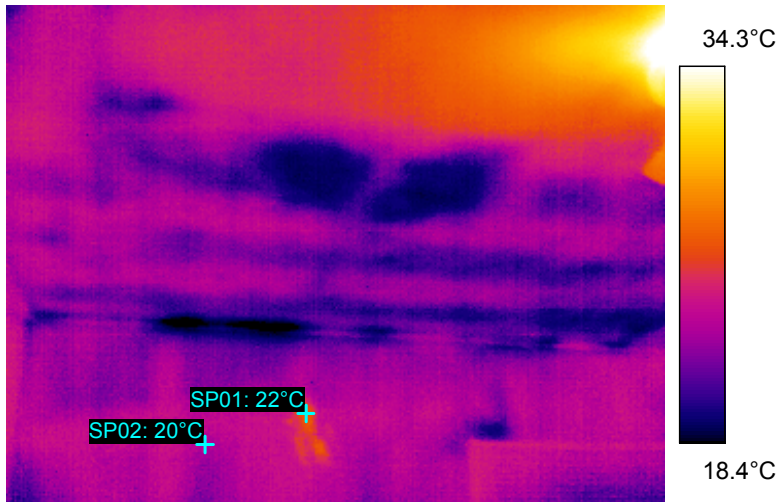
# Location: Apt. B, East bedroom

Notes:  
Warm anomaly found. 2 degree C temp. difference. Moisture reading found no results.

Could be electrical wires, found where old exterior incoming hydro used to be.  
Possible rodent infestation.

Investigate further, a destructive test may be needed.

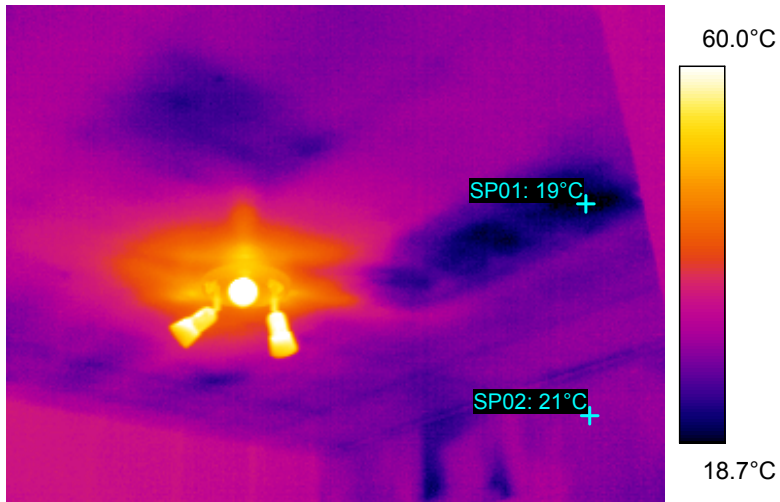
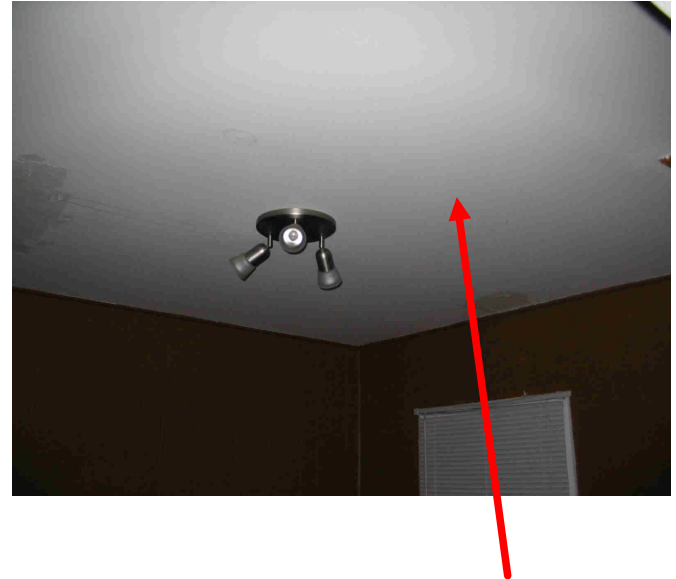
# Location: Apt. B, West bedroom

Notes:  
Cold air Ingress. 2 degree temp. difference. Insulation could be old and deteriorated.

Replace old insulation.
